**Project: Water management infrastructure, Sierra Rutile, Sierra Leone****Project Overview:**

**Project: Contract Mining Services, Sierra Rutile, Sierra Leone**

**Project: Mokula Waste Management facility, Sierra Rutile, Sierra Leone****Project Overview:**

**Project: Gangama North Tidal Embankments, Sierra Rutile, Sierra Leone****Project Overview:**

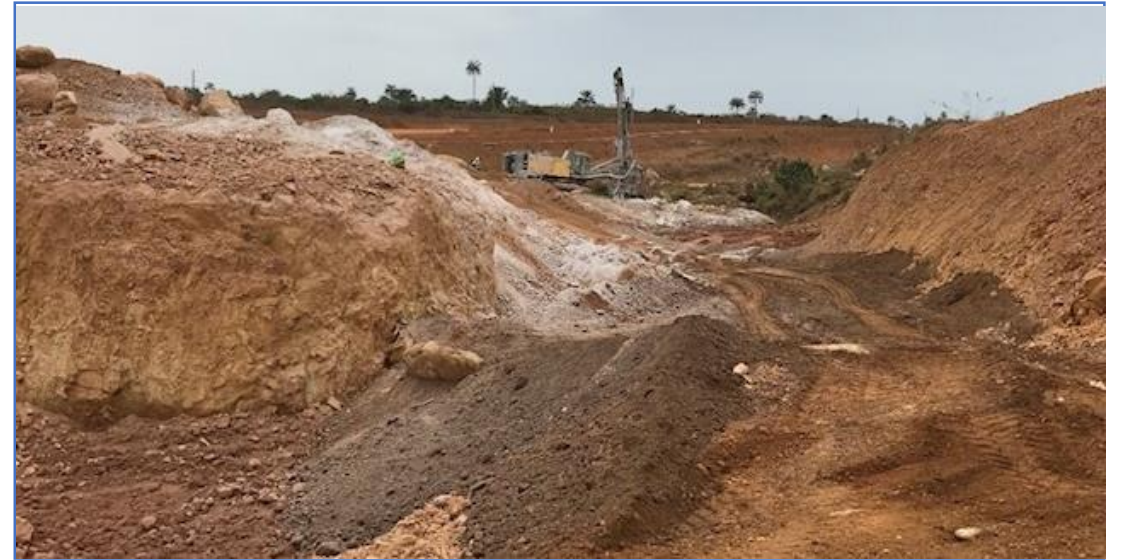
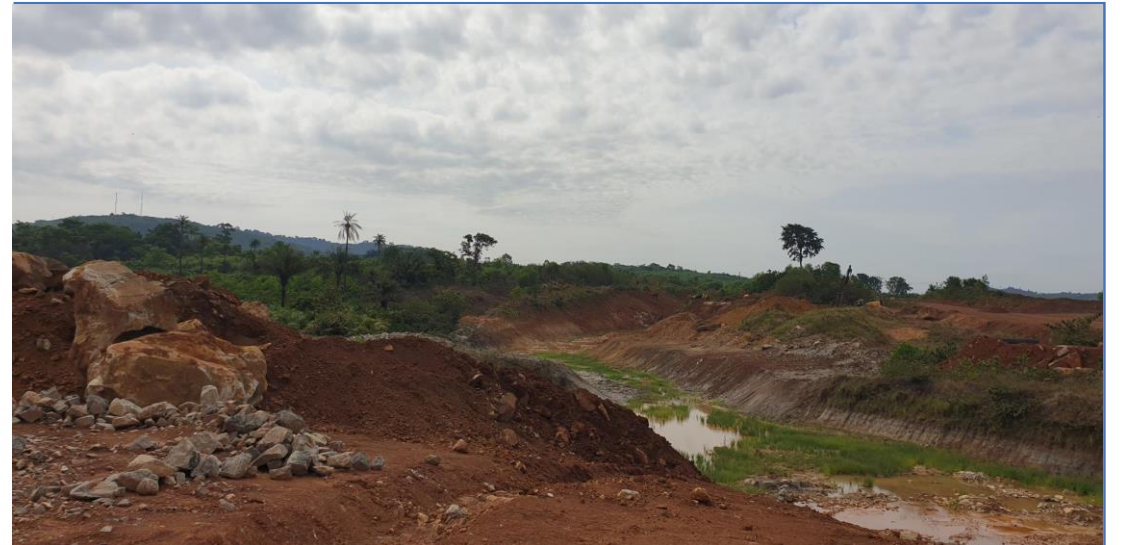
The works involved the drilling and blasting of approximately 100,000m<sup>3</sup> of residual bed rock and boulders obstructing the flow of water through storm water drainage channels at the mining locations.

The rock and boulders were generally in the lower sections and floor of the channels and accessed with a tracked Atlas Copco D55 drill rig over the full length of the drains.

A range of explosives were used depending on the type, quantity and economy of the scheduled blasts, including commercial bulk ANFO, high explosive boosters, cartridges and det cord. The isolation and distance between the boulders posed a significant challenge in blast economy and safety, resulting in many blasts scheduled on the same day, with constant exclusion zone enforcement to the surrounding areas and populations.

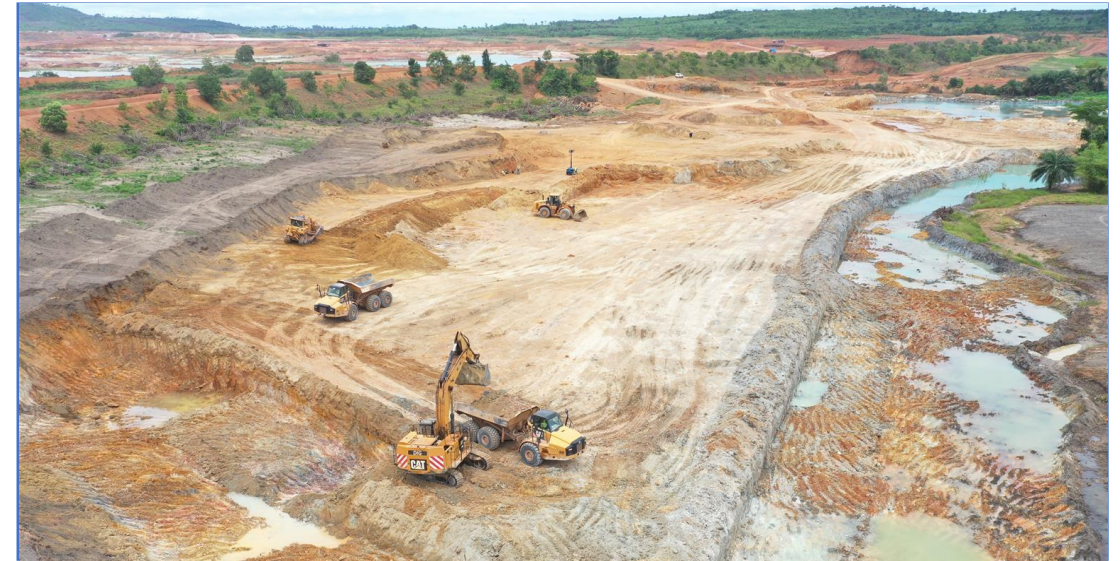
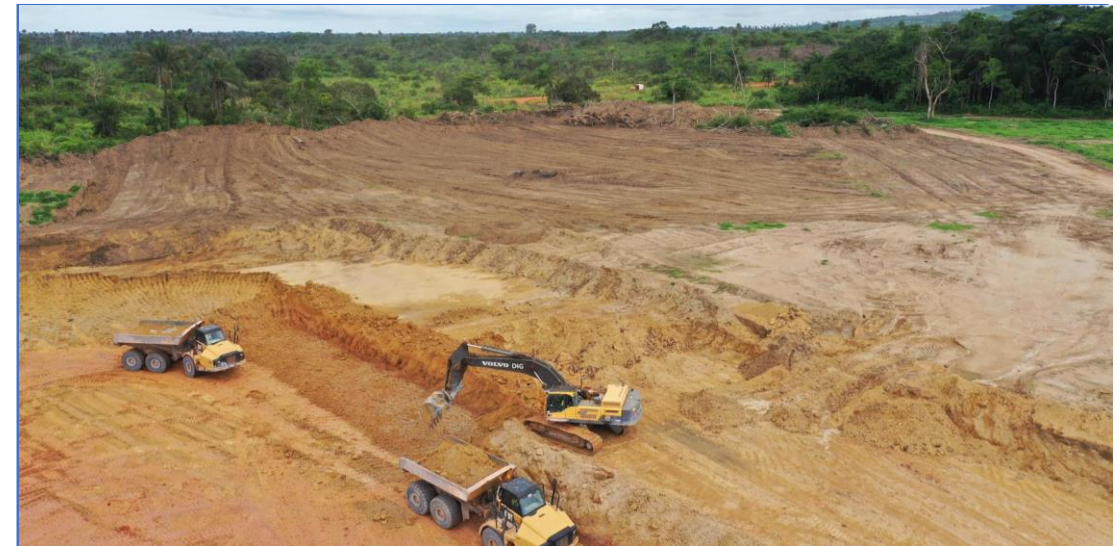
The contract required a 14,000WMT per day open pit mining operation 24 hours a day, 7 days a week, running in conjunction with the clients mining operation to build a rainy season stockpile for re-handle during inclement weather.

To achieve this DIG deployed a fleet of 2 prime mover excavators, 2 bulldozers, 12 Articulated dump trucks, a road maintenance team, and support equipment. DIG also deployed 7 expatriate supervisors and managers to ensure our clients' targets were met.

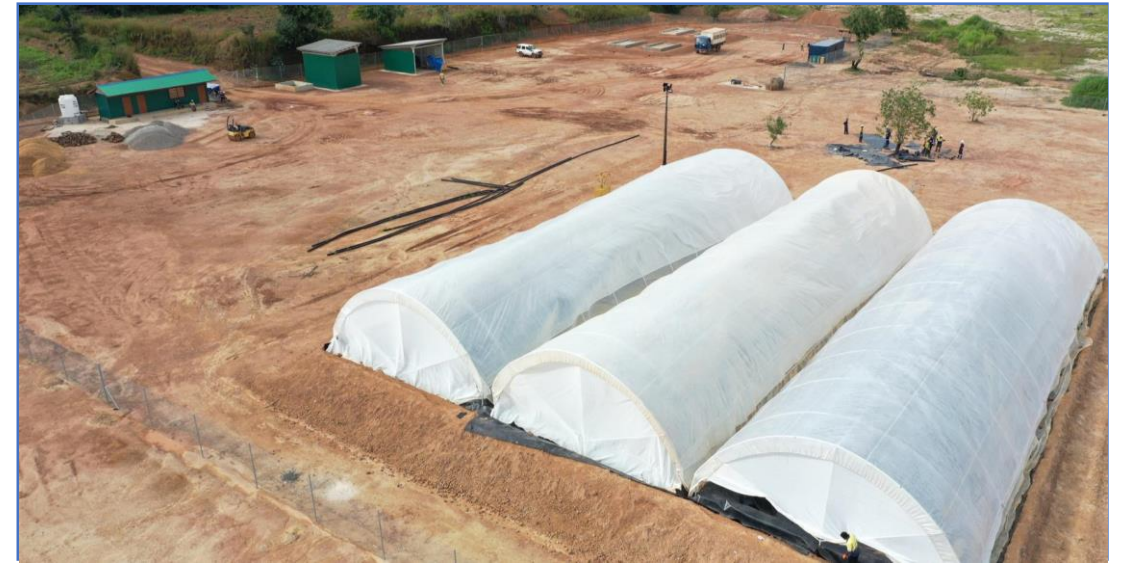
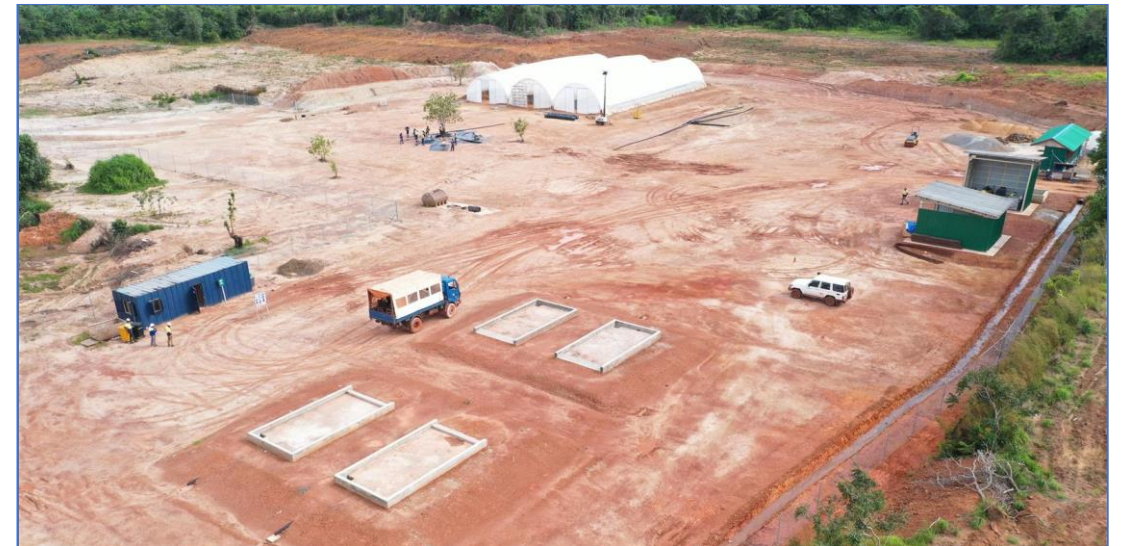
The contract required the procurement and installation of various reinforced concrete foundations for hydrocarbons waste oil storage, erection of Structural steelwork, hydraulically sealed burial cells for incinerated waste with leachate detection and separation systems, storm and foul water drainage and collection tanks, multi function incinerator and waste storage and separation areas.

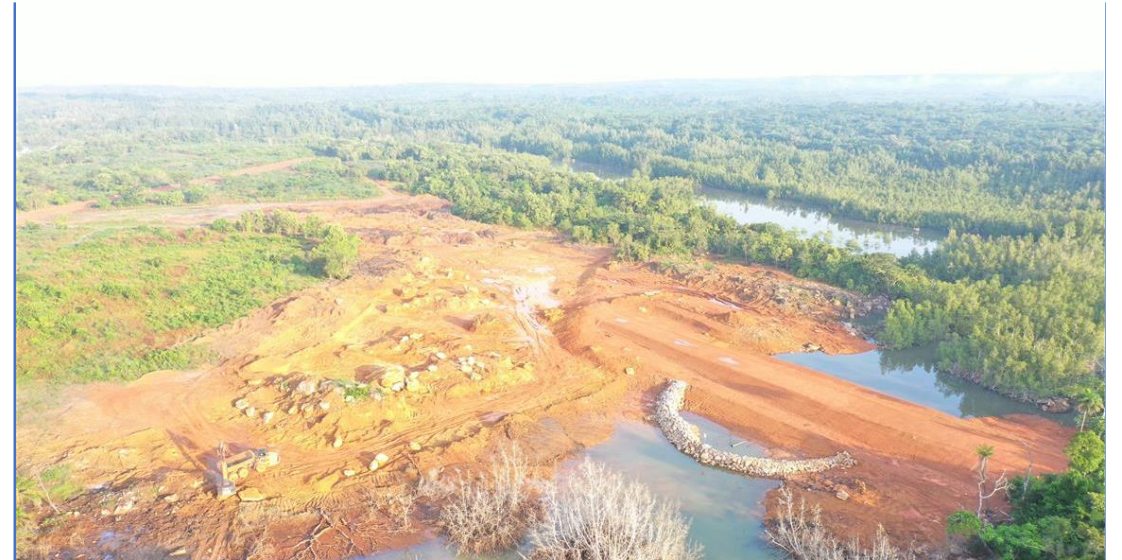
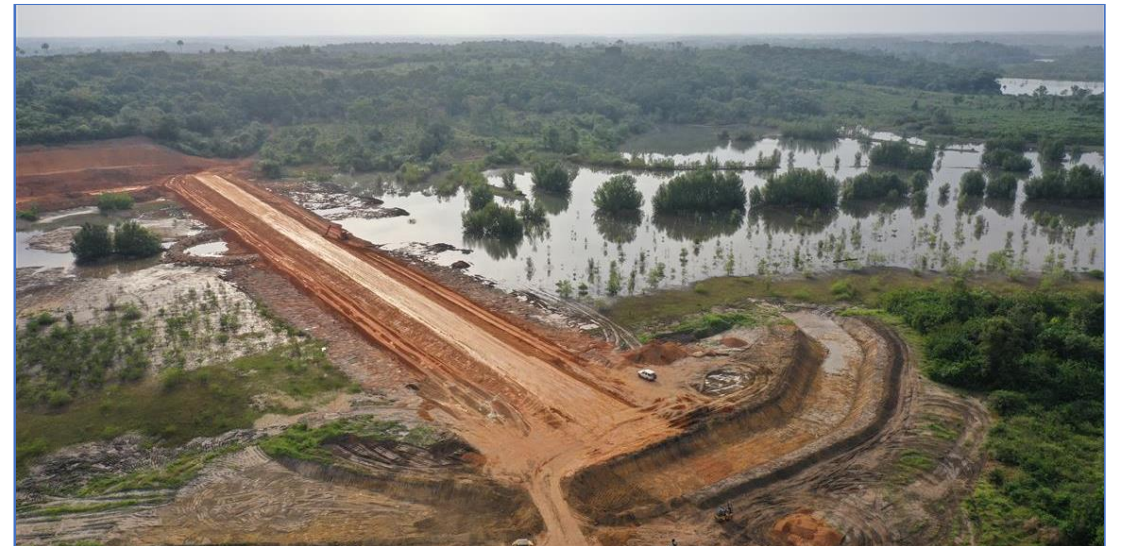
The contract required construction of 2 large tidal embankments as part of the wider storm water management system for the future mining areas. The embankments were both under tidal action on the upstream sides and part of the existing drainage infrastructure on the downstream side, construction therefore required a temporary coffer dam to isolate the footprint to enable their building.

The embankments were formed from lateritic material cut from adjacent spillways which were installed for mitigation under flood events, and valve controlled HDPE pipe outfalls were installed downstream of a decant filtration system to release water into the fragile mangrove ecosystems on the tidal side in normal operation.

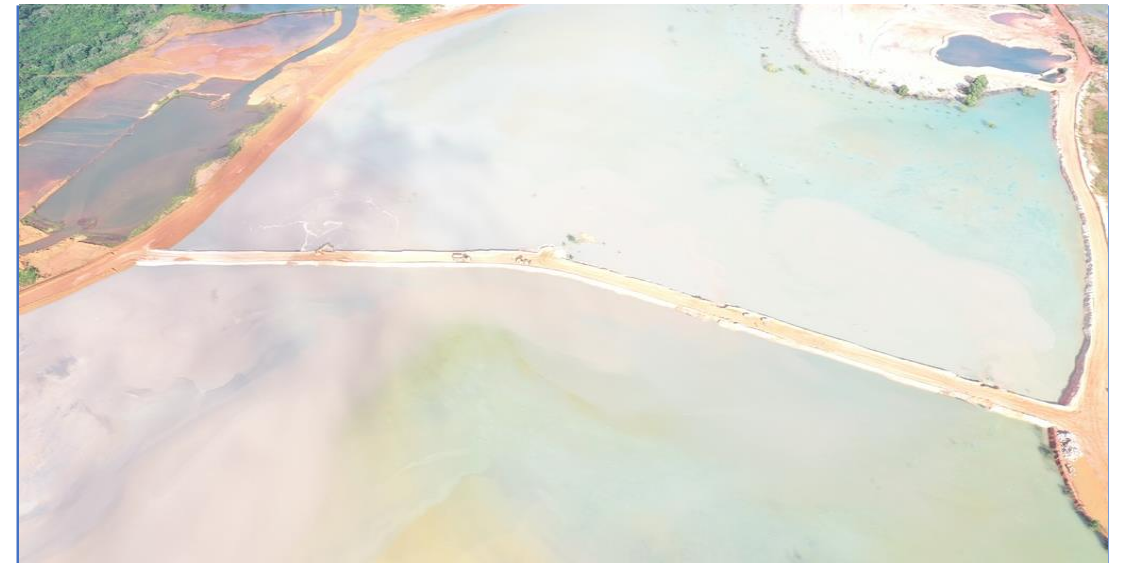
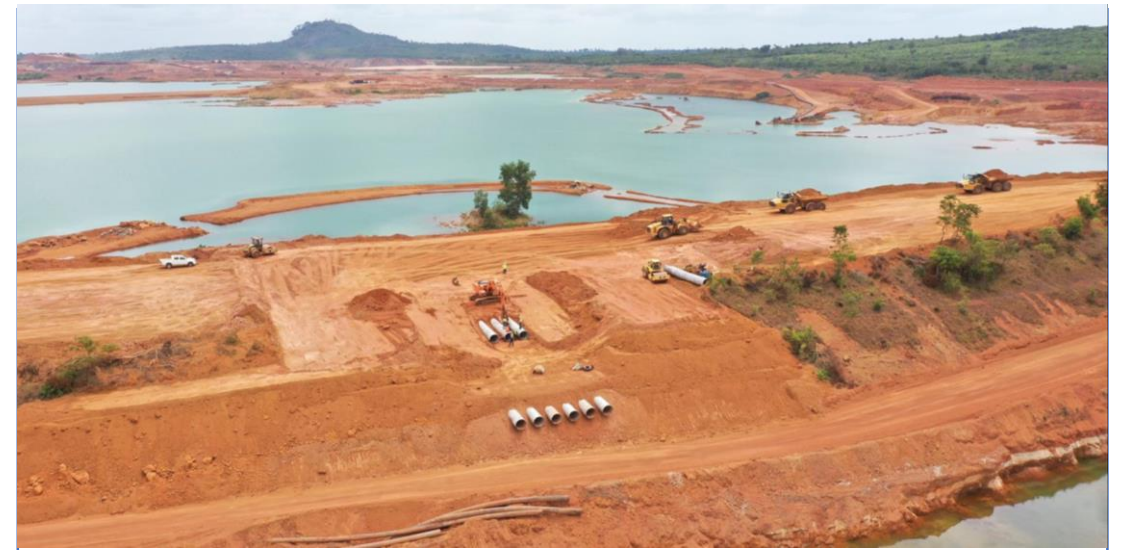
The contract was split into 4 sections and was part of the wider storm water and Tailings management strategy for the future and current mining areas.

60,000m<sup>3</sup> of redundant tailings were placed across an existing tails settlement pond, 10m wide and at a length of 500m to compartmentalise the structure and allow flexibility for the ongoing tailings deposition.

A 17,000m<sup>3</sup>, 10m wide storm water channel was excavated adjacent to CP1 slimes embankment to transition water downstream away from the structure more efficiently.

A 70,000m<sup>3</sup> void in the existing G1 wall was filled with lateritic material borrowed from adjacent pits. The wall was previously breached and washed out to allow drainage of active mining areas upstream. The closing of the void allowed a series of compartmentalised tailings depositions to be created for the ongoing operation of the process plant.

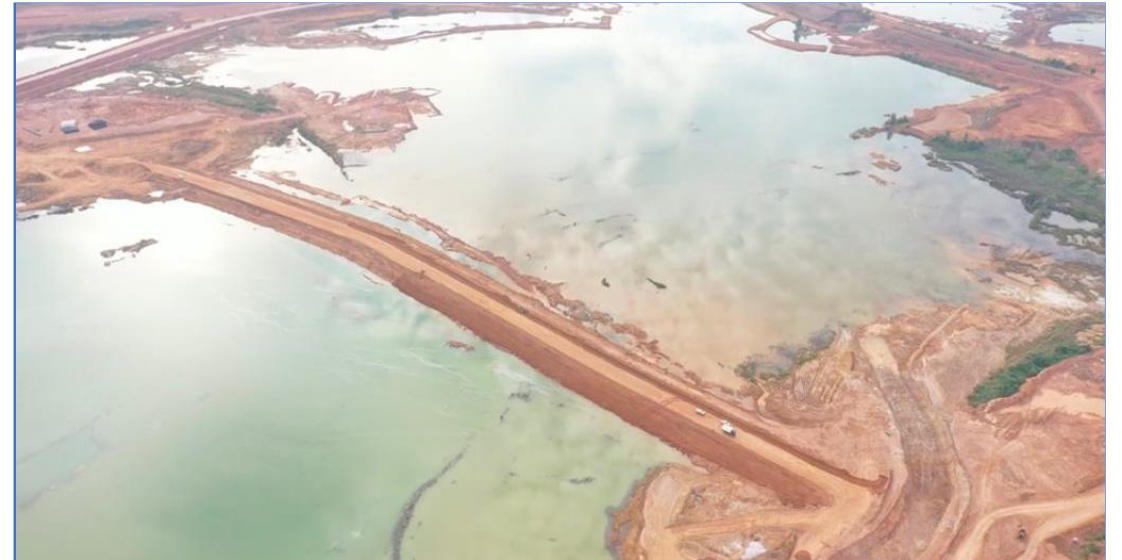
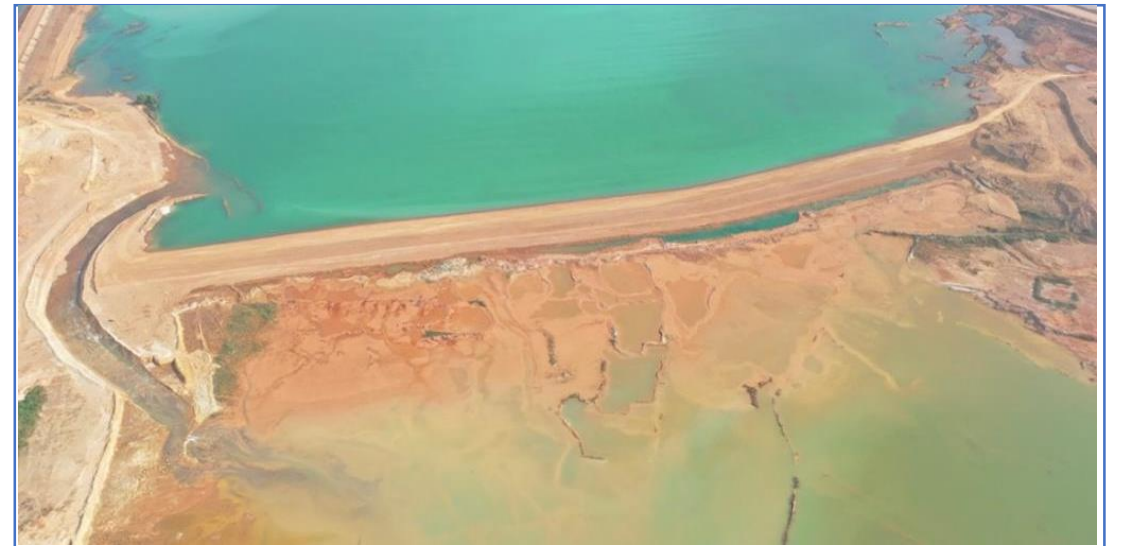
The embankment crossed 500ln/m of an active tailings deposition and raw water recirculation pond containing both slimes tailings and water to compartmentalise the next 2 years of plant tailings deposition options. The construction of the wall and to remove 45,000m<sup>3</sup> of unsuitable material from the footprint, a continuous coffer dam was constructed in advance of the works over the full length.

Total fill volume was 180,000m<sup>3</sup>, 25,000m<sup>3</sup> from the adjacent overflow spillway and the remainder from an adjacent lateritic source from borrow.

The completed embankment stood at an average of 9.5m tall, with an accessible road way of 12m width crest to crest.

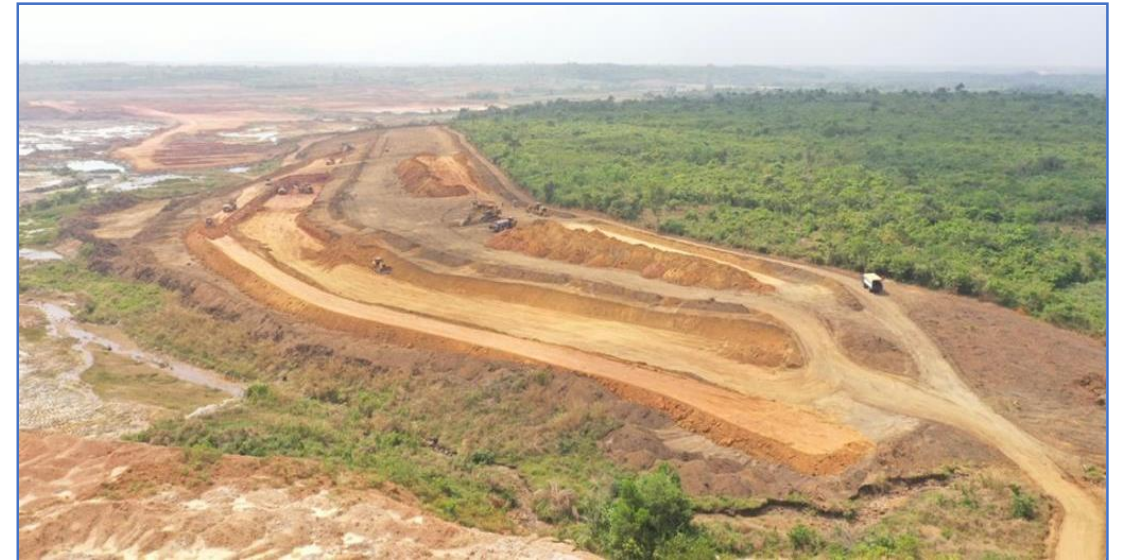
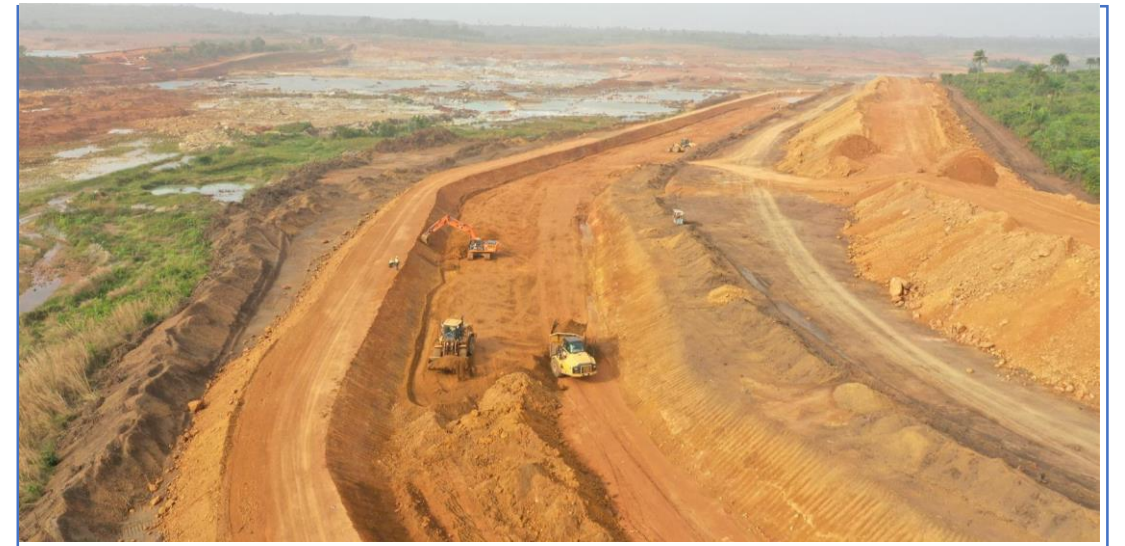
The works involved the excavation of 250,000m<sup>3</sup> of lateritic soil from the channel hauled and stockpiled along the channel shoulders, and a further approx. 60,000m<sup>3</sup> of drilling and blasting residual bed rock and boulders obstructing the flow of water through the channel.

The rock and boulders were generally in the lower sections and floor of the channels and accessed with a tracked Atlas Copco D55 drill rig over the full length of the drain.

A range of explosives were used depending on the type, quantity and economy of the scheduled blasts, including commercial bulk ANFO, high explosive boosters, cartridges and det cord. The isolation and distance between the boulders posed a significant challenge in blast economy and safety.
